Water District No. 1 Modeling Study

Town of North Castle, New York

WATER DISTRICT NO. 1 MODELING STUDY
TOWN OF NORTH CASTLE, NEW YORK

Prepared by
GHD CONSULTING SERVICES INC.
One Remington Park Drive
Cazenovia, NY 13035

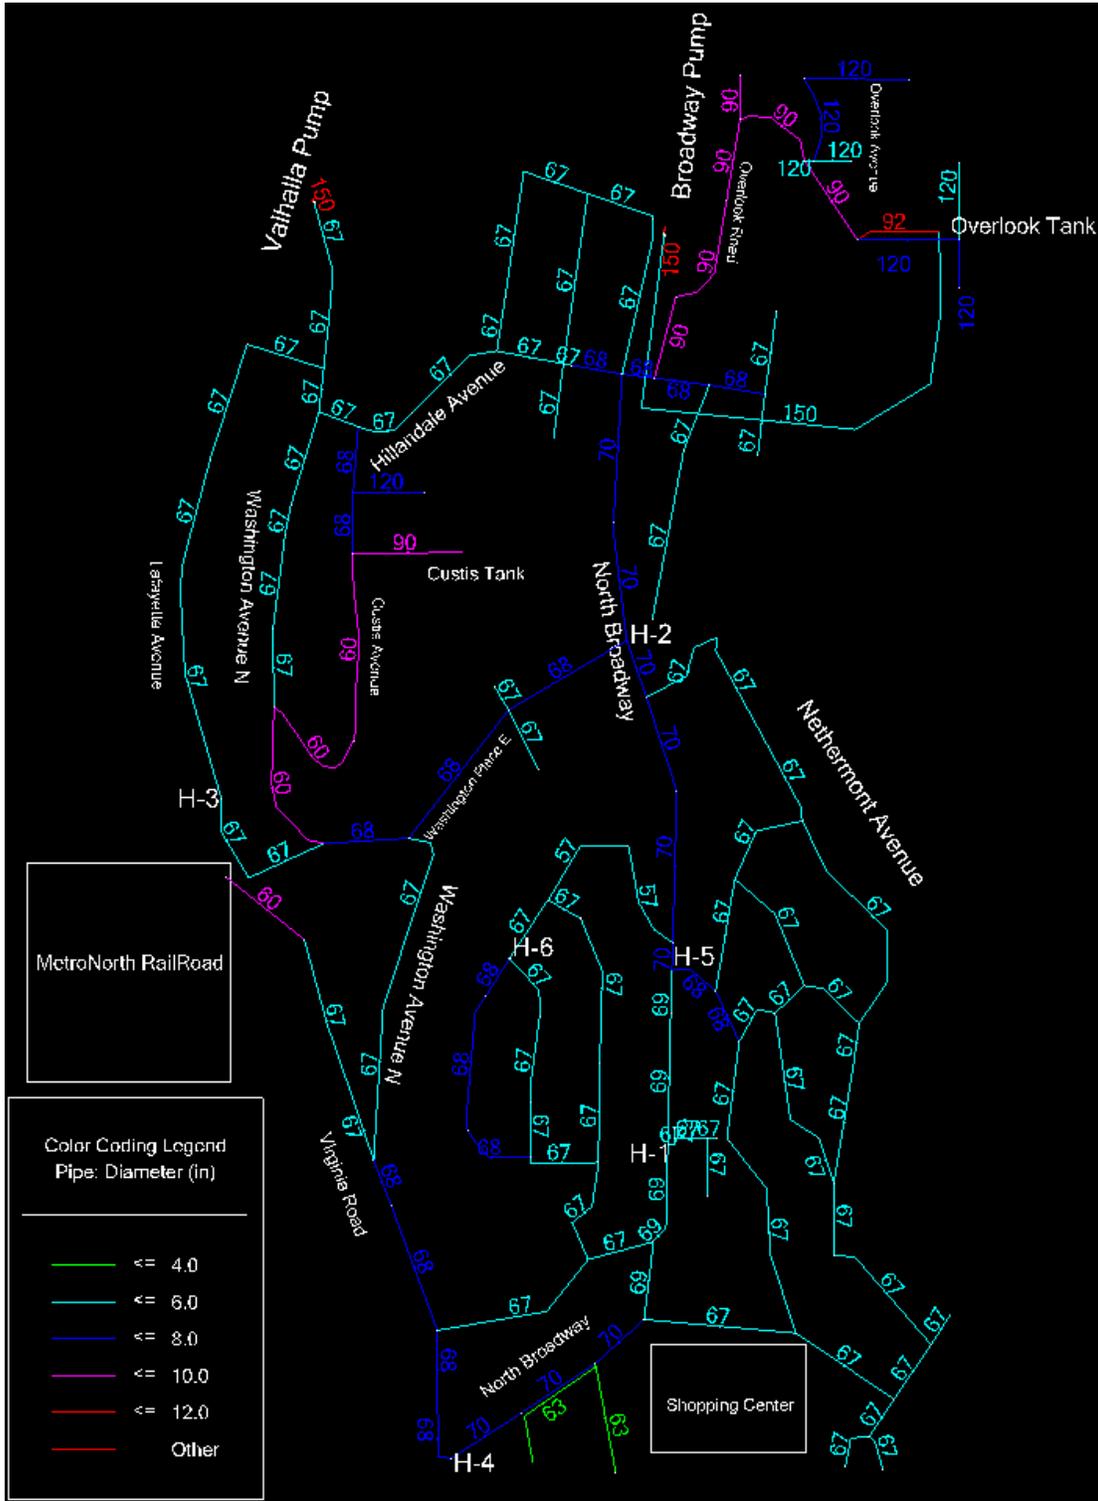
Appendix C - Hydraulic Model Map and Pre-Calibration Hazen C-Values Selected for Pipes in Model

Static Calibration Initial C (60 year old pipe)			
		Trend 1	Trend 2
C.I.	4"	93	75
	6"	97	79
	8"	100	80
	10"	105	82
	12"	110	85
D.I.	6"	130	
	8"	130	
	10"	135
